WORKS ON STRENGTHENING BRIDGE

Naser Morina

Abstract: The summary covers inspection, assessment and recommendations of repair and strengthening works for bridge no. 34 on N2 Road, Pristina - Blace section.

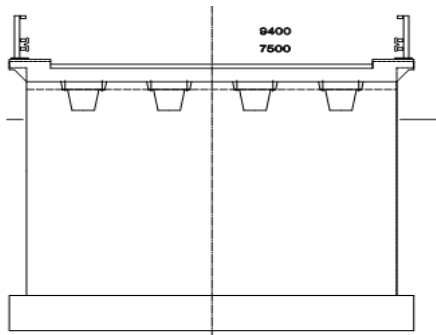
Figure 6.3. Cross section - Strengthened superstructure RC/Steel composite
Report from previous bridge 34 Inspection

The existing concrete edge beam and steel railing is in a very poor and deteriorated condition. Depending on whether strengthening of the superstructure or replacement of the bridge is selected, the following solutions are proposed:

1) Strengthening of the superstructure

For the strengthening solution it is proposed to replace the edge beam and walkway to a new integral structural concrete part of the bridge edge reinforced to sustain vertical and horizontal loads from the traffic. It is proposed to introduce a combined steel railing and crash barrier system, which meet international standard for bridge safety crash barriers.

It is proposed to carry out a standard polymer modified bituminous-based waterproofing membrane in two layers without concrete protection layer.

It is proposed to replace the existing asphalt pavement with new asphalt pavement based on a bearing course layer and a wearing course layer[8].

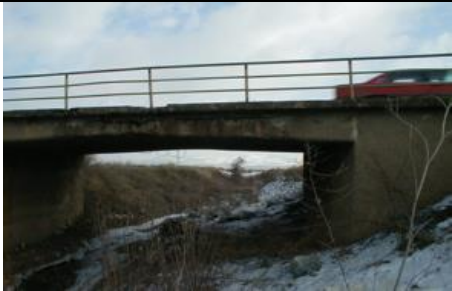
Figure - 4: Selected dokumentation

Coordinates:	42°31.75...21°09,75	
Road location	L.selo - Ferizaj - Main Road N-2	
Superstructure type	Mono-span, continual concrete structural slab	
Total spans:	1	
Length (m):	7,4	
Total Width (m):	9,4	
Road Width (m):	7

Approaches:	severity)	level 0 (good) to 3 (high)
Asphalt pavement	YES	2
Embankment	YES	1
Guard rail	NO

Abutments:	level 0 (good) to 3 (high severity)	
Type	Full height	
Joint with deck	NO	
Bearings and pedestal	NO	
Back wall	Cost in situ r. concrete	1
Wing walls	Cost in situ r. concrete	1
Pier:	level 0 (good) to 3 (high severity)	
Pier columns	NO	
Cap beam	NO	
Pedestals	NO	
Bearings	NO	
Superstructure:	level 0 (good) to 3 (high severity)	
Primary member	NO	
Deck structural	Reinforced concrete plate cost in situ	2
Joints	NO	
Deck elements:	level 0 (good) to 3 (high severity)	
Wearing surface	Asphalt	2
Sidewalk	YES (both sides 1.20)	1
Guard rails	NO	
Parapets	YES	2
