## STRENGTHENING OF THE CONCRETE BRIDGE

**Abstract:** The summary covers inspection, assessment and recommendations of repair and strengthening works for bridge no. 35 on N2 Road, Pristina - Blace section.

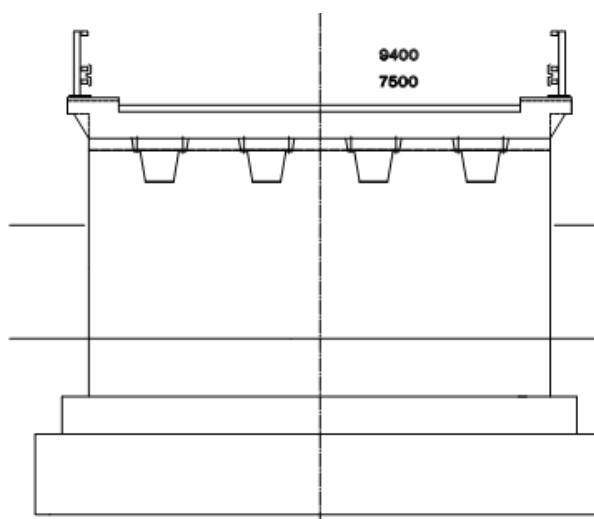
Figure - 5.3. Cross section - Strengthened superstructure RC/Steel composite

The existing concrete edge beam and steel railing is in a very poor and deteriorated condition.

It is proposed to replace the edge beam and walkway to a new integral structural concrete part of the bridge edge reinforced to obtain vertical and horizontal loads from the traffic. It is proposed to introduce a combined steel railing and crash barrier system, which meet international standard for bridge safety crash barriers.

It is proposed to carry out a standard polymer modified bituminous-based waterproofing membrane in two layers without concrete protection layer. The system is commonly used in Europe.

It is proposed to replace the existing asphalt pavement with new asphalt pavement based on a bearing course layer and a wearing course layer.
